Continuation of Wildlife Corridors in the Big Creek Estuary at The Cove

Prepared for Crossroads at Big Creek
August 2022, V 1.0

Hanan Ali
Land Restoration School
Hanali12@outlook.com

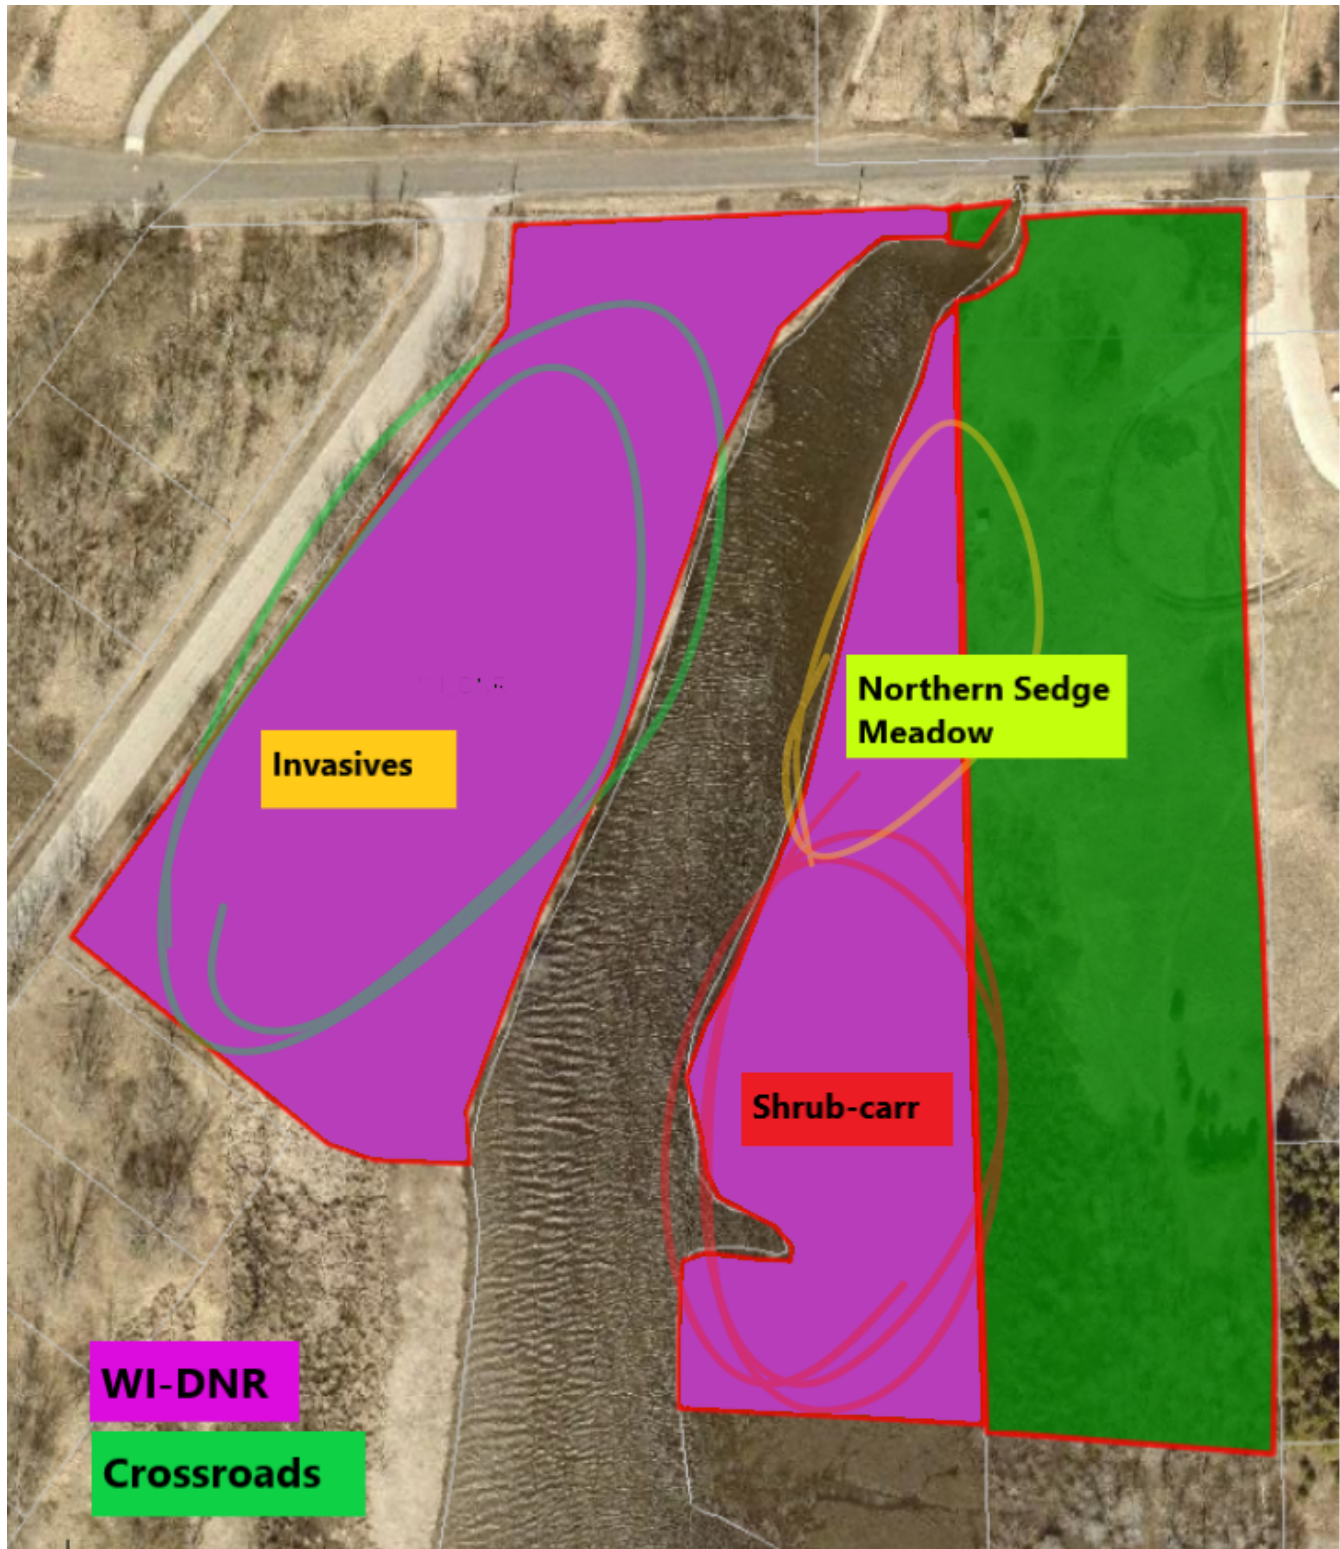
Sections along the estuary were chosen as the site of concern for this restoration plan. The sections are indicated by figure 1 below. The parcels were also sectioned off by the property boundaries of each side, as this information will be relevant in this paper.

1. The most obvious being the disconnect we see between the west side of the creek and the east side of the creek. The western side of the property lacks in maintenance and hosts invasives that were not found on the eastern side that borders Crossroads property. Purple loosestrife, Daylilies, and most importantly phragmites are not found on the other end and have a potential to spread. The area of concern on the west side of the property is indicated by the map

2. Furthermore, we noticed a good amount of dead ash in the Shrub-Carr section of the property as indicated on the lower end of this map. This dead ash opens up a canopy of sunlight that could potentially enable the growth of unwanted exotic woody invasives.

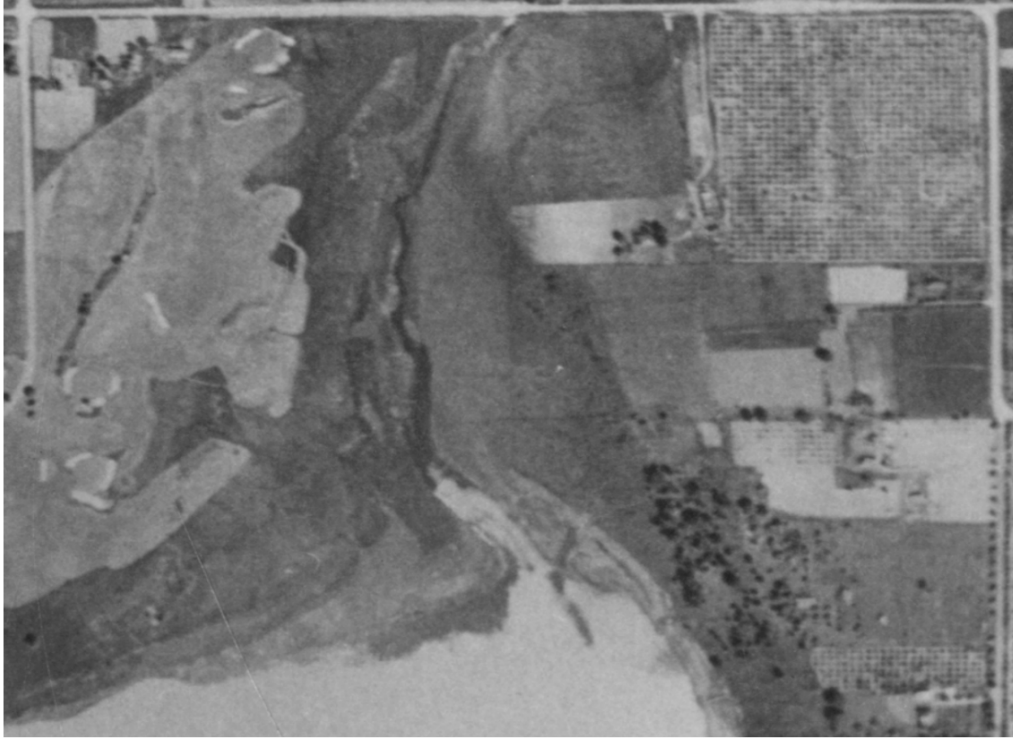
1938

Previous images from 1832, compared to images of 2021, indicate that the body of water has drastically changed within these time periods. We can tell that the body of water has been channeled throughout the years, and along with that we can see fluctuations within the water level. These fluctuations play a significant role in the type of habitats that this site offers. As water levels rise some woody species may die. This in-turn creates new habitats that are conducive to wetland species in the Shrub-carr portion.

We can see that surrounding this site there was most likely a golf course of sorts on the south western side of the map. On the northeastern part, the land was previously used as agriculture and also includes new fill in recently.
